Urgent Field Safety Notice

Medtronic Cobalt™ and Crome™ Implantable Cardioverter Defibrillators (ICDs)
and Cardiac Resynchronization Therapy Defibrillators (CRT-Ds)

Software Update Available to Correct Potential for SmartSync Telemetry Error

Medtronic reference: FA1236

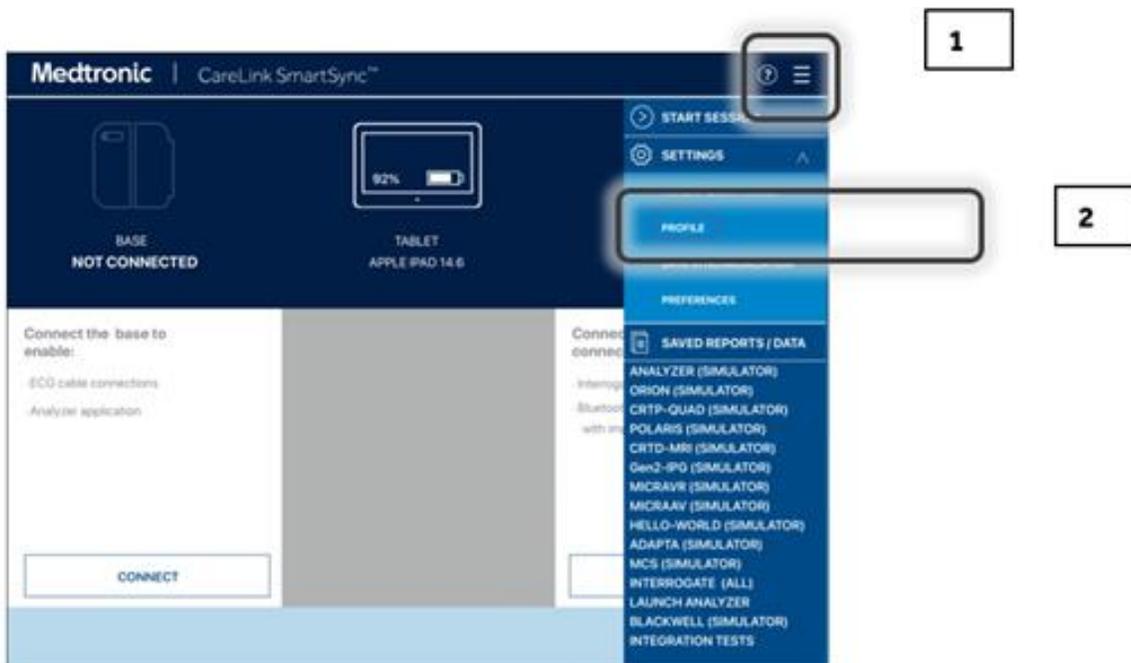
If the software update for this issue has already been installed, you will see the following versions listed:

- The Common/Platform application version is 3.6.4 (or higher)
- The Cobalt/Crome application version is 6.0.3 (or higher)

3 - Updated application versions
