Urgent Field Safety Notice

Reveal LINQ™ with TruRhythm™ Insertable Cardiac Monitoring Systems

Brady & Pause Detections Disabled Following Partial Electrical Reset
Software Update Available

Medtronic Reference: FA978 Phase II

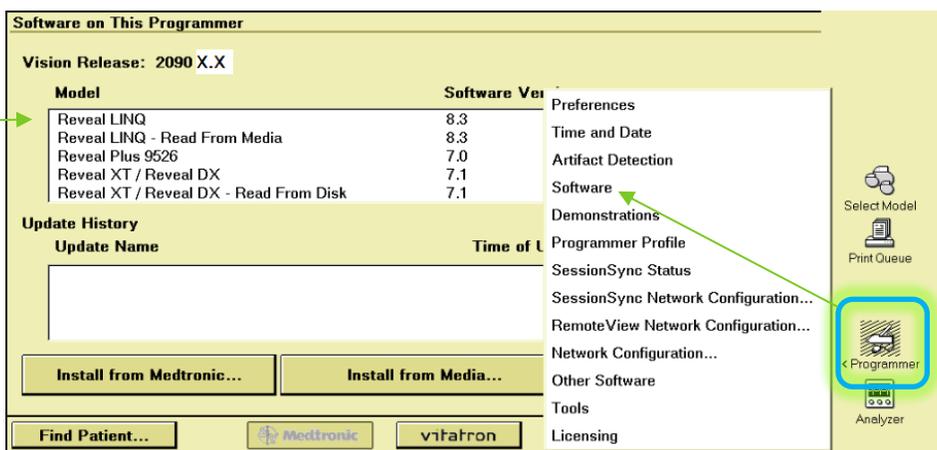
From the Find Patient screen on the programmer, Tap the Programmer Icon, select "Software," and scroll through the list of installed applications to find Reveal LINQ Software Version 8.3.
