URGENT FIELD SAFETY NOTICE

Surgical Microscope Leica M220 F12
FSCA Identifier: CAPA-HER-MD-21-002
Additional Retention Fixture to secure M220 Optics Carrier

Heerbrugg, November 2nd, 2021
Leica Microsystems (Schweiz) AG

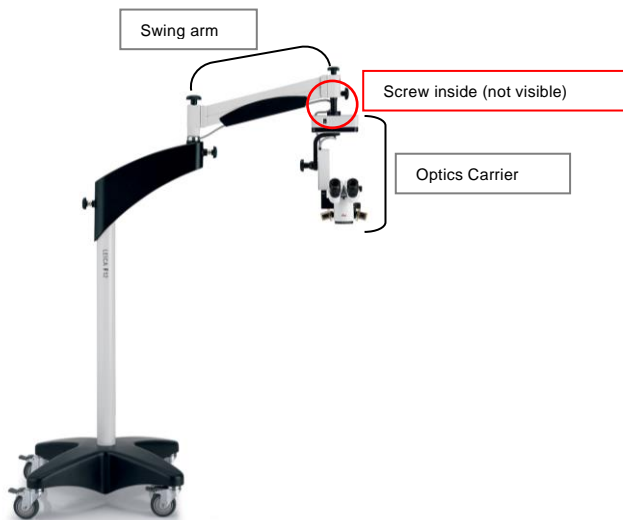
Figure 1: Leica M220 F12 Surgical Microscope

The identified defect is a mechanical part failure with the screw that connects the optics carrier to the free end of the swing arm (see Figure 1).

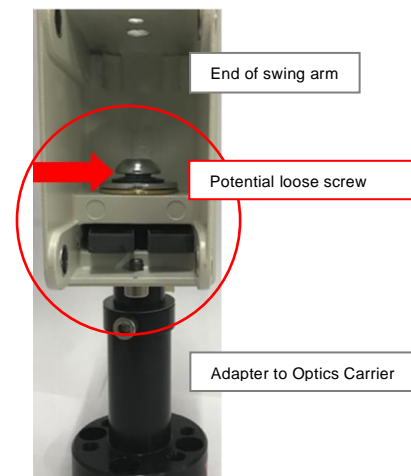
Figure 2: Potential loose screw connecting the swing arm with the optics carrier

Leica Microsystems has performed a thorough root cause investigation which has identified the cause of the observed issue to be insufficient securing of the screw that connects the swing arm with the optics carrier (see Figure 2). This screw was found to not be secured by an adequate amount of high strength thread adhesive to ensure a reliable connection of the swing arm with the optics carrier. This inadequate securing of the swing arm was not identified during production and final inspection of the M220 swing arms. These swing arms were then built into M220 F12 Surgical Microscopes manufactured before March 9th, 2017*. Due to this, the screw that connects the swing arm with the optics carrier has loosened over time (see Figure 2) and subsequently resulted in the optics carrier falling. Based on the results of the root cause investigation the probability of occurrence of this defect for the end user is very low.

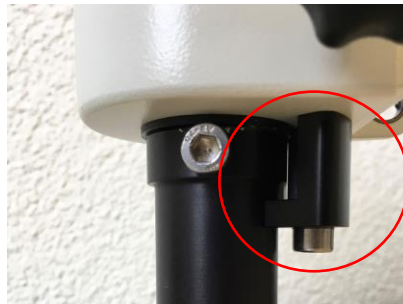
Figure 3: Detailed view of the retention fixture as an additional means of securing the M220 Optics Carrier

As a matter of precaution Leica Microsystems has chosen to initiate a field safety corrective action to provide a retention fixture (see Figure 3) to be added on all Leica M220 F12 Surgical Microscopes manufactured before March 9th, 2017 to ensure patient safety and customer satisfaction.

Your Leica Microsystems representative will provide you a retention fixture as an additional means of securing the M220 Optics Carrier free of charge.

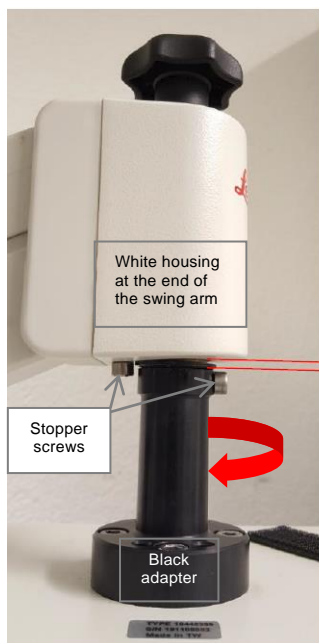
- If the gap between the black adapter and the white housing at the end of the swing arm becomes bigger than 3mm (see Figure 4) or a free rotation of the optics carrier is possible for more than 360° (see Figure 5): → **Immediately stop using the device!**

Figure 4: Detailed view of gap between black adapter and white housing of swing arm.

A gap bigger than 3mm or possible free rotation of the optics carrier for more than 360° indicates that the screw holding the adapter is loose and there is a potential risk that the optics carrier becomes disconnected and potentially fall.

In this case the M220 F12 can no longer be used.

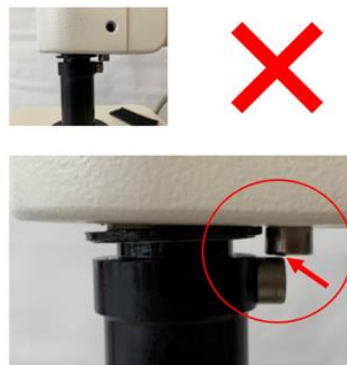
Figure 5: Detailed view of stopper screw when M220 F12 is faulty: Stopper screws are not effective and allow free rotation > 360°. → **Immediately stop using the device!** The M220 F12 can no longer be used.

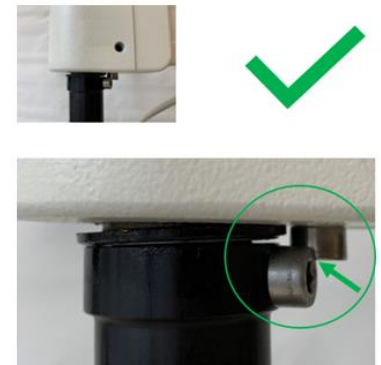
Figure 6: Detailed view of stopper screws when M220 F12 is according to specification: Stopper screws are effective and do NOT allow free rotation > 360° → **Instrument can be used as intended.** There is no risk for the optics carrier to disconnect from the swing arm and potentially fall.

With a gap of less than 3mm, and it is NOT possible to rotate the optics carrier 360° the screw holding the adapter is NOT loose and the device can be continued to use as intended.
